# **Reserve Study Level II**

**Prepared for Treasure Island Country Club**  
**2023 Fiscal Year**

Prepared by CEDCORE, LLC  
Version 1  
© 2022 CEDCORE, LLC

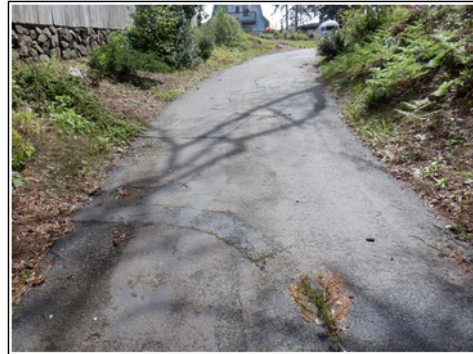
Condition: Assorted Condition

Generally fair condition of asphalt surface with some localized areas that are dry and faded. We recommend regular seal cycles be completed to maximize the life of asphalt. Seal coat and crack filler protects against damaging elements, such as oil, water, UV, etc. As routine maintenance ensure that oil spills are promptly cleaned and drains and grates are free of debris and properly functioning. Reserve funding recommended for regular cycles of seal coat and local areas of repair every 5 years.

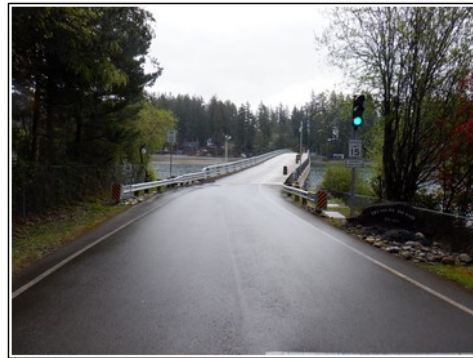
**Site/Grounds - Asphalt: Resurface**

Condition: Fair

Good to fair condition of asphalt, with no unusual cracking, waviness or deterioration noted. We recommend regular cycles of repair and seal coat to maximize the life of the asphalt. Reserve funding recommended for eventual overlay.

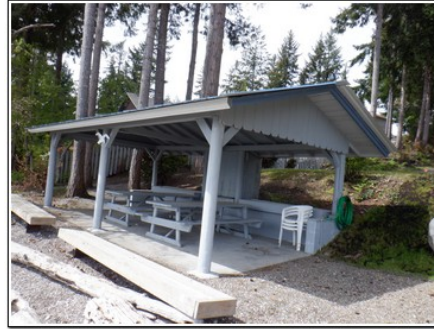
**Building Exterior - Beach Picnic Shelter: Replace**

Location: Beach  
 Quantity: 1 Allowance  
 UL: 50  
 RUL: 5  
 Current Cost: \$15,000  
 Condition: Functional  
 Funding Basis: Funded based on Association direction

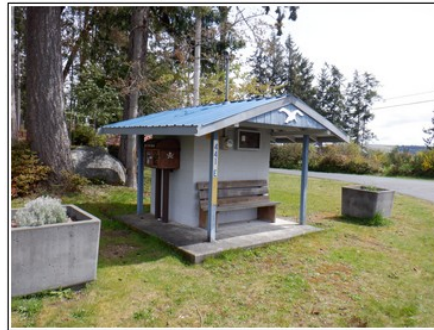
## Recreation - Benches: Replace

Location: Various  
 Quantity: 4 Each  
 Current Cost:  
 Condition: Assorted Condition  
 Funding Basis: Unfunded, operating expense

Good condition with no unusual deterioration or instability observed. No history of concern. Repair or replace as needed from the operating budget.

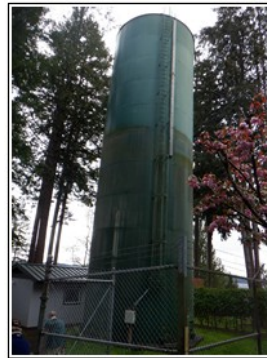
## Site/Grounds - Fence, Chainlink: Replace

Location: Around Water Tank  
 Quantity: 200 Linear Feet  
 UL: 40  
 RUL: 8  
 Current Cost: \$6,400  
 Condition: Good  
 Funding Basis: Funded based on the typical life expectancy

Good condition of the chain link fencing. The life expectancy of these units are approximately 40 years. Reserve funding recommended.

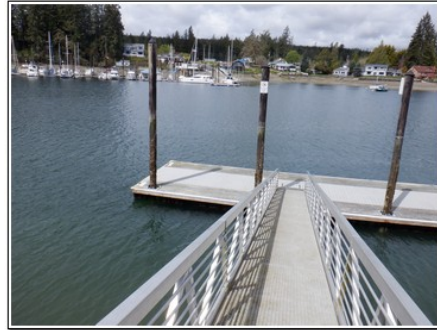
## Recreation - Floating Dock Pilings: Permitting

Quantity: 1 Allowance  
 UL: 50  
 RUL: 0  
 Current Cost: \$22,203  
 Condition: Good  
 Funding Basis: Funded based on Association direction

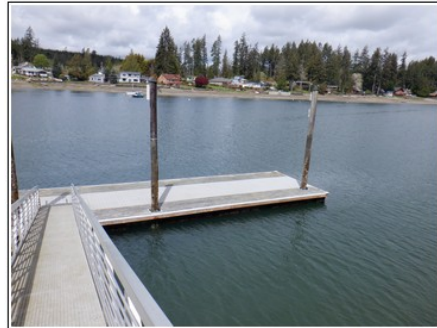
## Recreation - Floating Dock, Pilings & Ramp: Replace

Quantity: 1 Allowance  
 UL: 50  
 RUL: 3  
 Current Cost: \$407,000  
 Condition: Good  
 Funding Basis: Funded based on Association direction

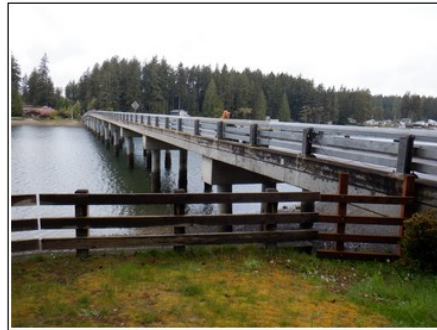
## Site/Grounds - Guardrail, Wood: Replace

Location: Dock Approach  
 Current Cost:  
 Condition: Assorted Condition  
 Funding Basis: Unfunded, operating expense

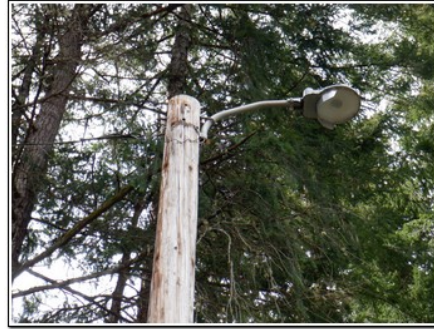
## Site/Grounds - Lights: Pole, Replace

Condition: Functional

Funding Basis: Unfunded, not Association responsibility

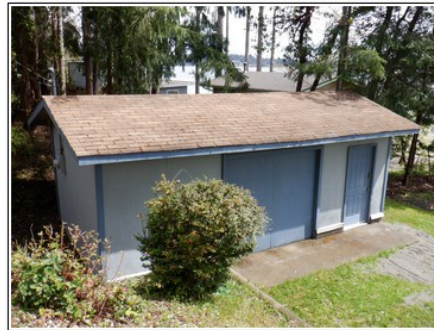
## Building Exterior - Maintenance Shed Roof: Replace

Condition: Functional

Funding Basis: Funded based on Association direction

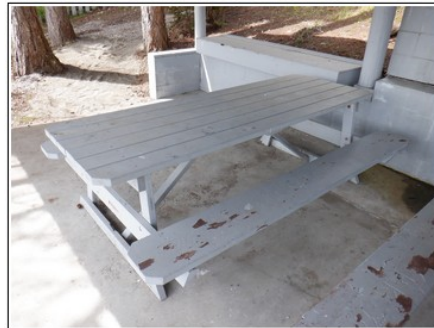
## Recreation - Picnic Table: Replace

Condition: Good

Funding Basis: Unfunded, operating expense

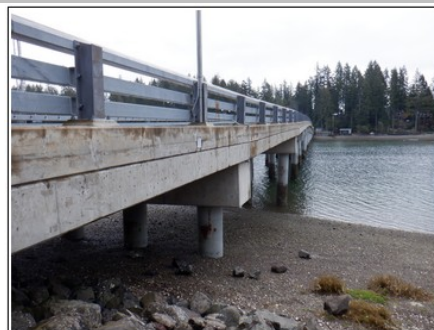
## Site/Grounds - Piling, Bridge: Inspection & Repairs

Condition: Good

Funding Basis: Funded for repair

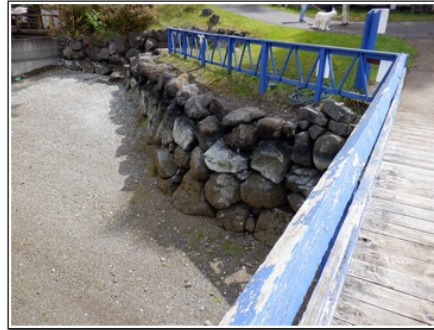
## Site/Grounds - Rock Bulkhead: Repairs

Condition: Fair

Fair condition with no known instability or concerns identified. Should conditions change, we recommend a thorough evaluation be conducted by a qualified geotechnical engineer.

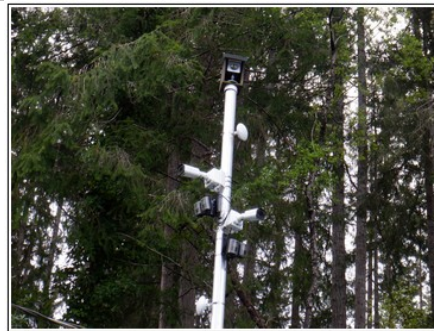
## Building - Security System Upgrade

Condition: Good

This component may be used to fund partial replacement as needed. These systems typically become technologically obsolete before they become nonfunctional.

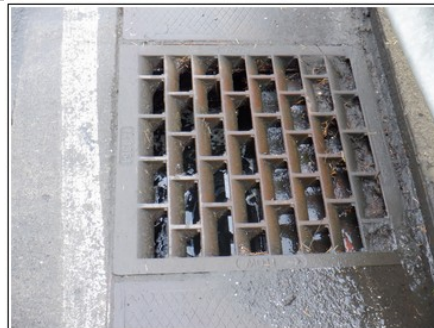
## Mechanical & Equipment - Storm Water Catch Basins: Clean Sump & Replace Canisters

Condition: Good

Funding Basis: Funded based on the typical life expectancy

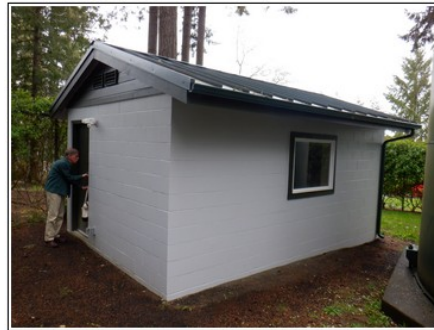
**Building Exterior - Water Well Houses: Repairs**

Condition: Assorted Condition

Funding Basis: Funded based on Association direction
